Support for Sustainable Development (SSD)

Terminal report of Gibe-kechema Irrigation Based Integrated Development Project

(1st January 2019 – 30th March 2022)

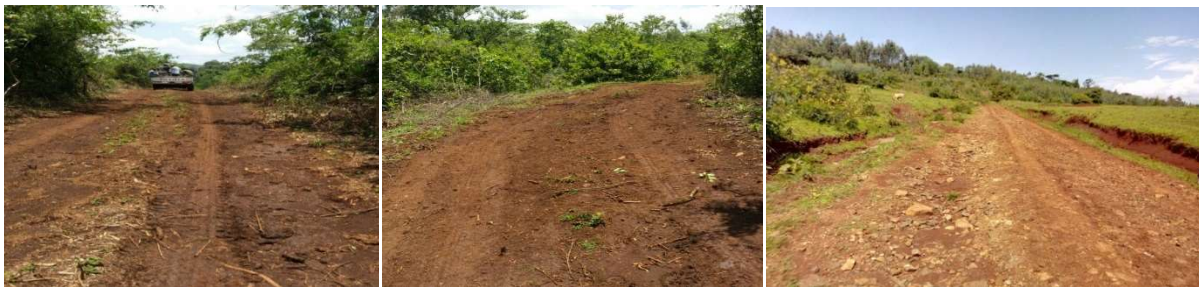
Construction of access road is also one of the planned activities during the reporting period, and accordingly length of 650m and width of 7m access road has been constructed to enable truck and machine movement. The road is now gives service to transport construction materials and as well as for field vehicle movement to the project construction site. Even though the plan for the quarter is 6 km, the project performed 650m road which is enough to reach at the current headwork construction site. In addition the project maintained 265m farm road which is damaged by the unexpected rain so as to transport construction materials and to ease small vehicle movement to the site.

Fig 2: Access road maintained

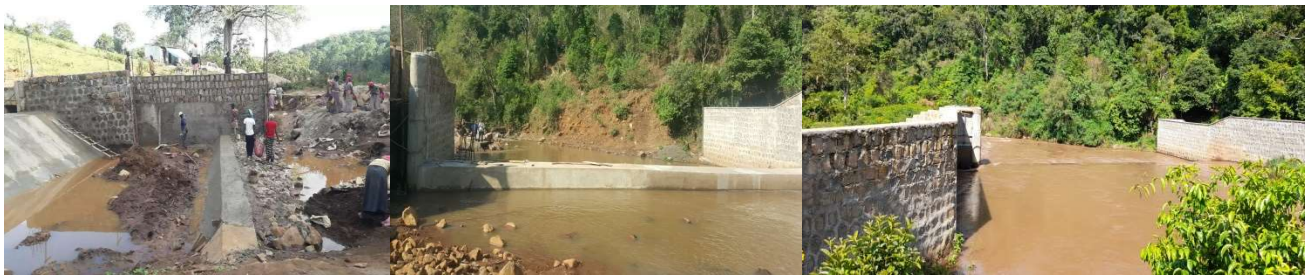
The diversion weir consists of the weir body which is built across the river bed is the main structure that helps to raise the river height to certain level and guide the water to be conveyed into the main canal through the intake gate to the farm areas and upstream and downstream apron structures. The diversion weir structure is designed to have 27m length and 100% or fully completed in the year. The construction work had been done according to its design by keeping its quality and workmanship by using quality materials like river sand and 12 Ø iron bar and skilled labourers so as to withstand any external force and serve for the designed period (25 years).

Figure 3: Weir body constructed & completed

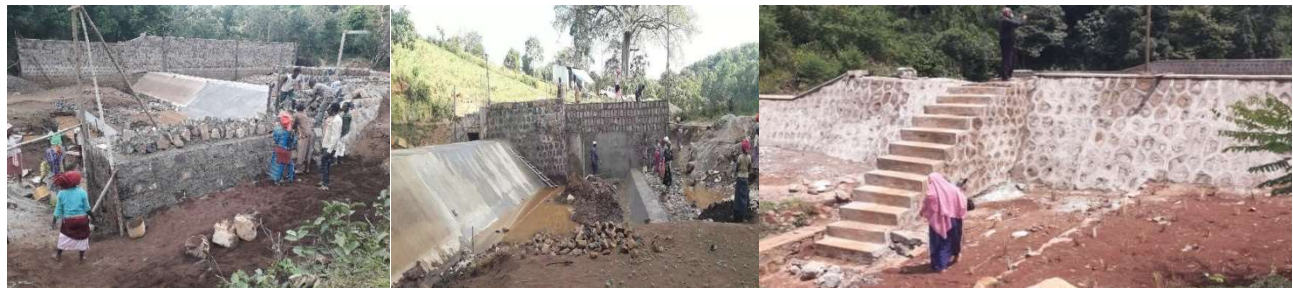
It was planned to construct 60m long retaining wall masonry structure both sides of the river to support the weir and protect river side erosion at the head work areas. Accordingly, about 80m long retaining wall which is 40m long at each side have been built and completed in the project period. During the period, 33m³ of foundation excavation and 24m³ masonry work for stair construction (to serve for climbing to the top of the retaining wall to open and close the main canal gate) and 58m² of pointing work have been done and fully completed.

Fig 4: Retaining wall & walking stair completed

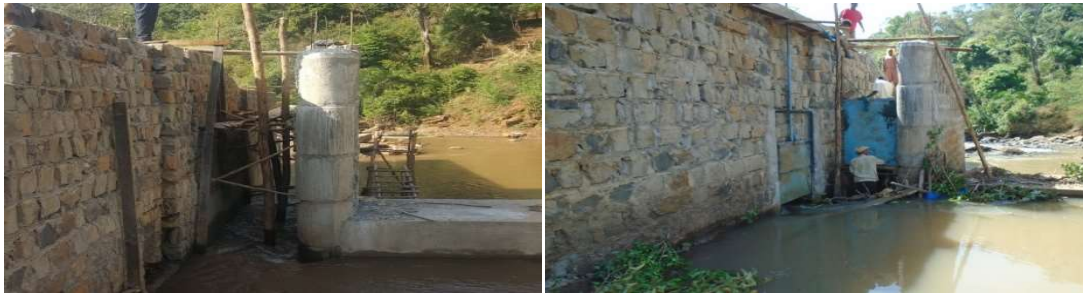
The intake structures is the area where the water is conveyed through to the main canal and the sluice gate is also used to manage or control the amount of the conveyed water as per the farmers demand to irrigate their farm plots. These two structures have been constructed at the retaining wall at left side where at the junction of the

weir and retaining wall structures. As a functional unit of the diversion system, intake and sluice gates have been incorporated in the design both having different functions. In this reporting period the operation slab at the top of the retaining wall, sluice and intakes gate have been fixed and serving for the intended purpose.

Figure 5: Divide wall constructed b/n retaining wall & weir body and sluice gate fixed

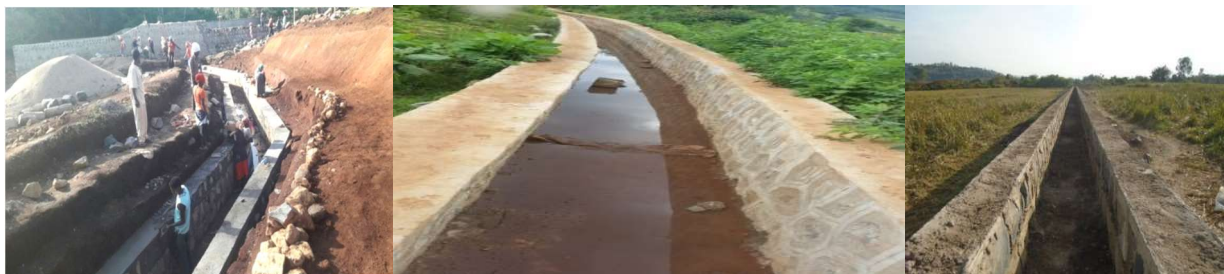
The main canal just starting and living the retaining wall at a length of 135m has planned to be constructed with masonry structure. In the reporting period, 272m of the main canal lining is done for the purpose of avoiding scouring effect of the diverted water as it comes with high speed while entering the main and branch canal system. In addition, pointing and plastering work of 285m² area of the main and branch canal is done so as to fully complete the canal structure.

Figure 6: Lined canal constructed

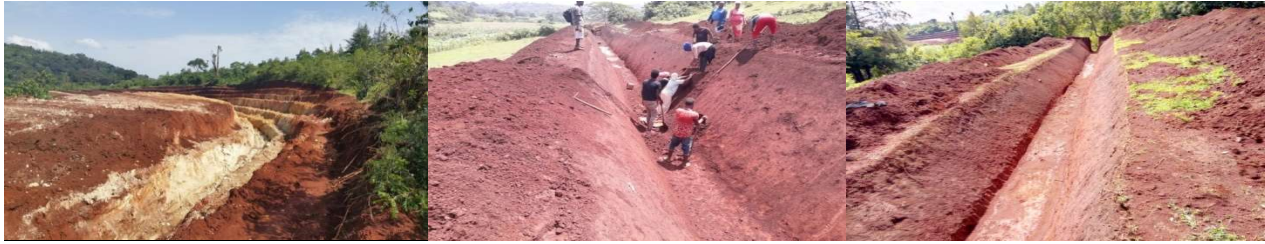
Main canal excavation is one of the project activities planned in the year to be done simultaneously with the construction of the head work structure. Accordingly, in the reporting period about 1.46km main canal is planned to excavate and 100% of it or 1.46km long main canal is excavated and completed including all slope cutting and soil cart away activities. The project used excavator machine to the canal which has high cut or very deep and difficult to excavate with labour force. As a result, out of 1.46km main canal about 453m high cut canal areas excavated by machine and 847m by human labour.

Fig 7: Main canal excavated by machine and human labour

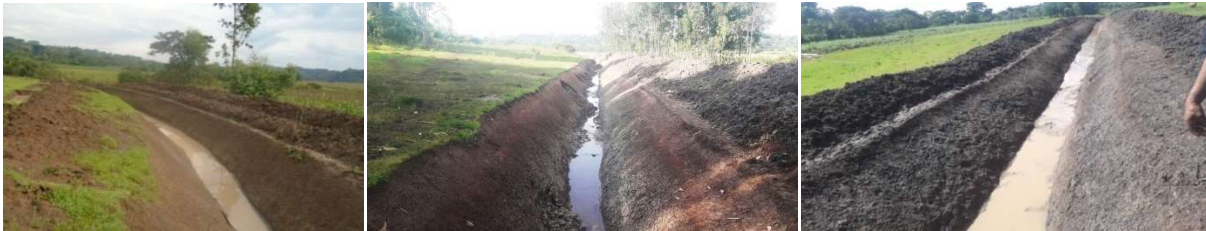
It was planned to execute 3km branch canal excavation after crossing main asphalt road in the left and right side direction. Thus the main canal is branched into two just starting after crossing the main road from Jima to Mizan. Accordingly, a total of 3.805km branch canal is excavated in both directions to address the farm areas found left and right side of the gibe river. All the necessary work like canal slopping and soil cart away from the canal edge are fully done completed.

Figure 8: Branch Canals excavated

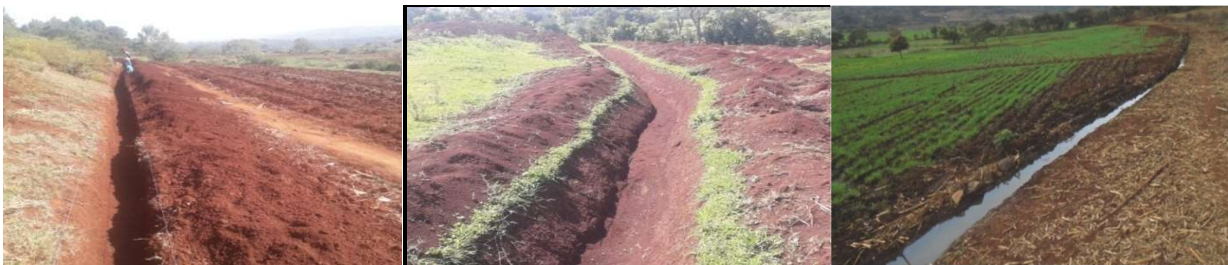
Secondary canal is serving as water distributary directly to the farmland from the main and branch canals. These canals branched from main or Branch canals starting from the division boxes to feed water to the farm channels and then to the farm areas. Hence, it was planned to excavate 4km long secondary canals and 3.888km of them have been excavated and completed which is almost 100% of the plan.

Figure 9: Completed Secondary Canal sections

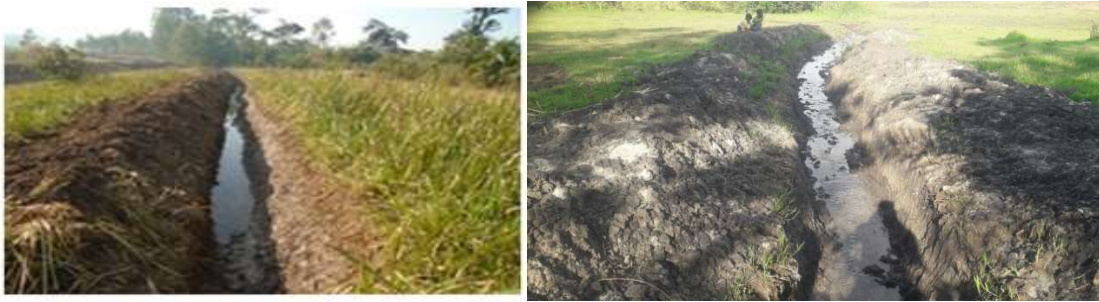
Drainage canals are planned to dispose excess water accumulated in the field which will be caused due to either run off as a result of rain fall or excess application of irrigation water. These canals will be laid in the farm

depending on the topographic nature of the farmland. The existence of drainage canal also serves to avoid water logging effects. AS to avoid water logging in the farm areas due to excess water application and to drain the canal water during off period, drainage canals would serve in collecting and disposing this water directly in to the natural gullies. The other use of the drainage canal is take off the floods collected by the cut off drain to safely drain into the small gullies and rivers without permitting any scouring of lands. In the project periods, 3.5km drainage canal is planned, of which, 0.71km of drainage canal excavation is performed at different canal areas and swampy areas. The reason of deviation from the plan was the revision of this structure and plan to do what is needed to actually dispose of the flood and canal water during off period.

Fig 10: Drainage canals excavated

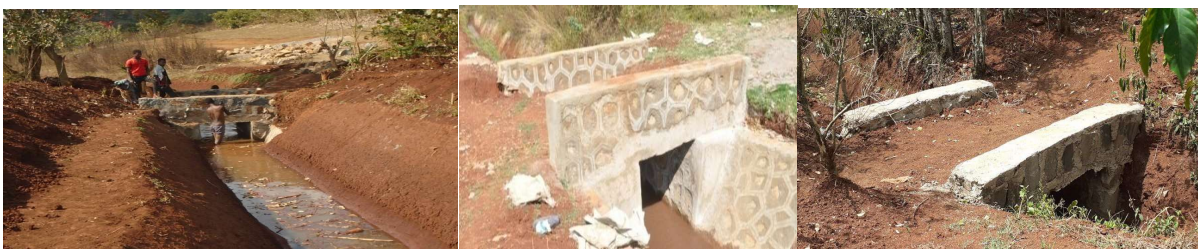
Foot Bridge is smaller in size as compared to culvert structures but contributed to protecting the canal from damage by animals while crossing it. The foot bridge structure is built only to pass animals and human to get into the farm areas during wet and dry seasons but not allowed for vehicle. During the project periods, Construction of three foot bridges were planned to facilitate access to the farmland and cross the project area by foot. However, depending on the length of branch canals to be prepared, the number of the structure was exceeding the plan. Accordingly, 6 foot bridges were constructed both sides of the branch, main and secondary canals to ease movements of human as well as animal to in and out of the farm areas.

Figure 11: Completed Foot bridges

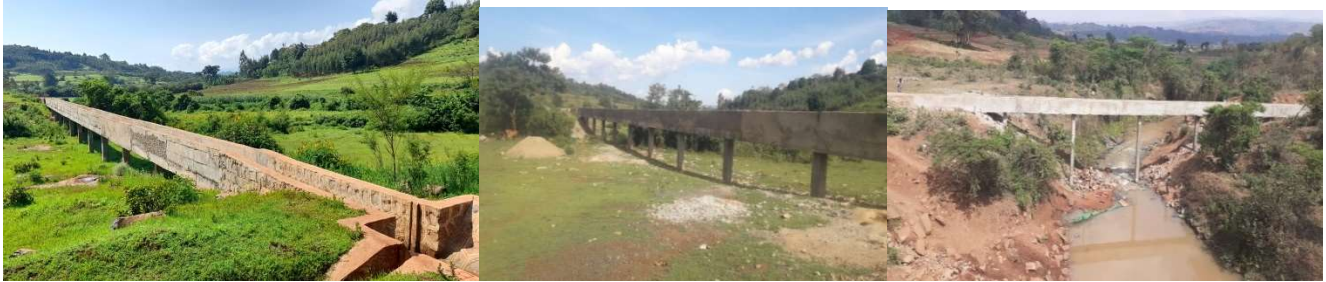
The flume structure is used to cross the depressed land areas and natural river to convey canal water into the other parts of the canal areas. It was planned to build two flume structures one is to cross the low land areas at main canal few distance from the weir area and the other is to cross the gibe river to the other part of farm areas. To

this, the total length of the flumes constructed was 135m which is 94m of canal length constructed at the depressed area suspended over to reach at next main canal and 41m long flume structure to across the gibe river to the right side of the farm areas. And hence, 100% of them were constructed and completed.

Figure 12: Depressed area and Gibe River Crossing Flume construction completed

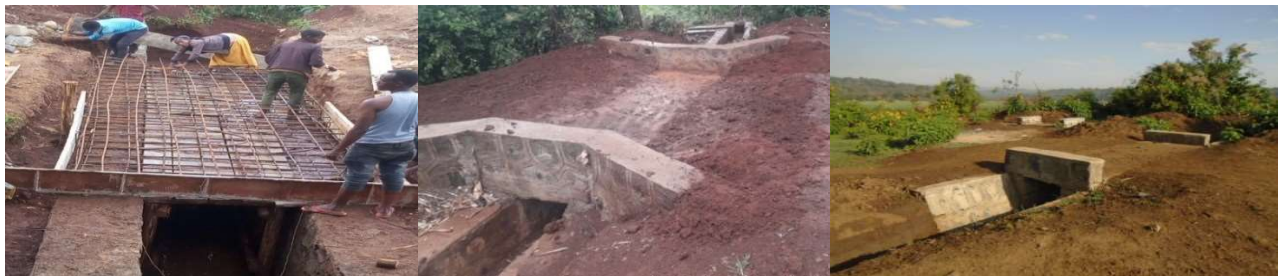
The road culvert structure is built to use as a passing road for vehicle, animal and human to cross the canal line. In order to protect the damage of the canal line and its structures, road culvert is playing great role to save canal by inviting the three mentioned risk factors to come and easily cross and join the place where attempted to get. Road culvert is mostly built for to use as passing road or way for vehicle.

During the reporting periods, it was planned to build 5 road culverts on the main, branch and secondary canals, however, 8 road culvers have been constructed on the canals both at the left and right side where more human and animals use to cross the canal and join the farm as well as to access the river water for animals to drink. This is achieved 160% of the plan. The over accomplishment is due to community request to newly add during 3 months project extension.

Figure 13: Completed Road culverts

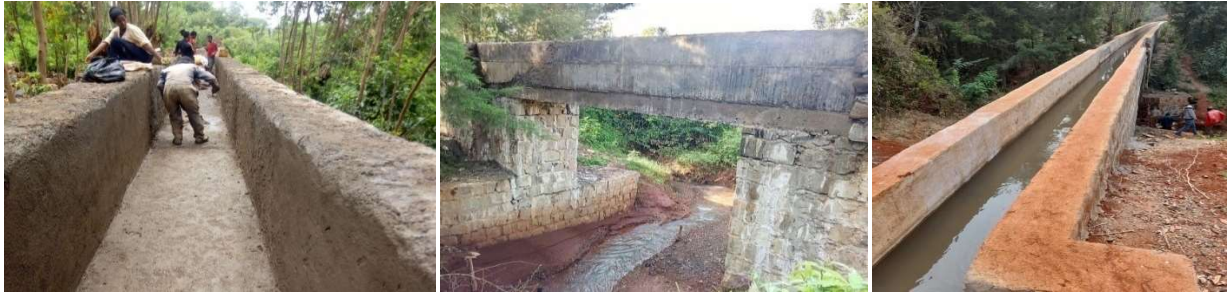
The purpose of drainage culvert is to dispose the incoming surface runoff towards the natural gully or river. In addition to this it can be also serves as a crossing way or road for the animals and human through it to the farm areas. Thus, this structure is built to keep the canal safe during the rainy season when a lot of water is also coming and inundating the farm areas.

In the reporting periods, 6 drainage culverts are planned to construct on the canal lines but 10 were constructed at left and right side canal lines so as to drain upland water to the other side of the canal areas.

Figure 14: Drainage culvert constructed

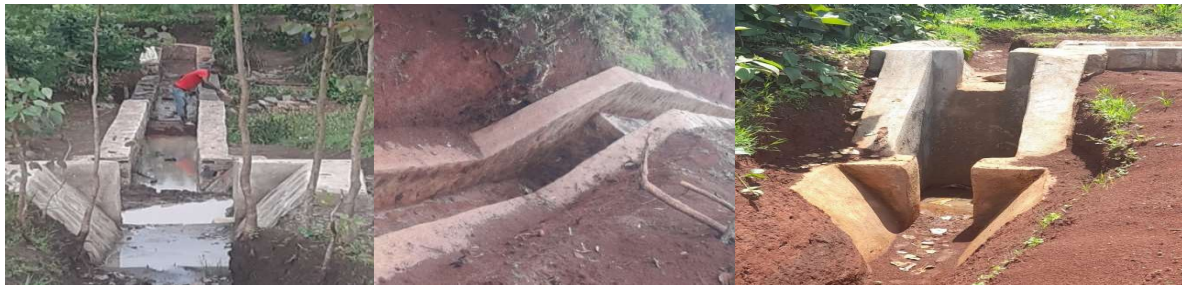
Drop structures were planned to construct on the branch and secondary canal to drop the canal the canal line so as to maintain the designed canal free board and attain consistent water flow in the canal to the farm areas. In the reporting periods, it was planned to construct 22 drop structures, however due to shifting the canal line to the upper side and to attain good flow of the canal water to the other side of the farm areas, only 6 drops and 26m long chute masonry structure are constructed.

Figure 15: Drop Structures constructed

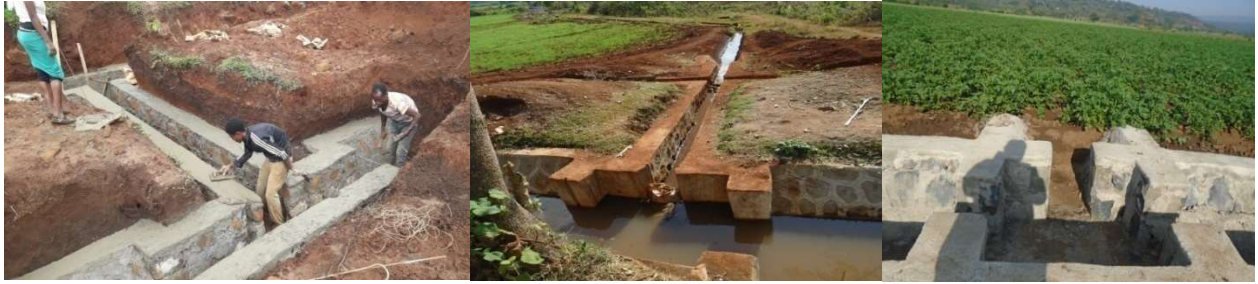
Drop structure is planned to be built on the main, branch and secondary canal to easily turn or open the conveyed canal water to the farm channels and then to the farm plots or planted crops. One division box structure may serve to let water to the farm areas for two or more directions controlled by division box gates. It is allowable only to take water from this structure. In the reporting period, it was planned to construct 28 water flow regulating division boxes structures to the farm land. However, 30 division boxes were built on main, branch and secondary canals.

Figure 16: Division boxes constructed on main & Branch Canal

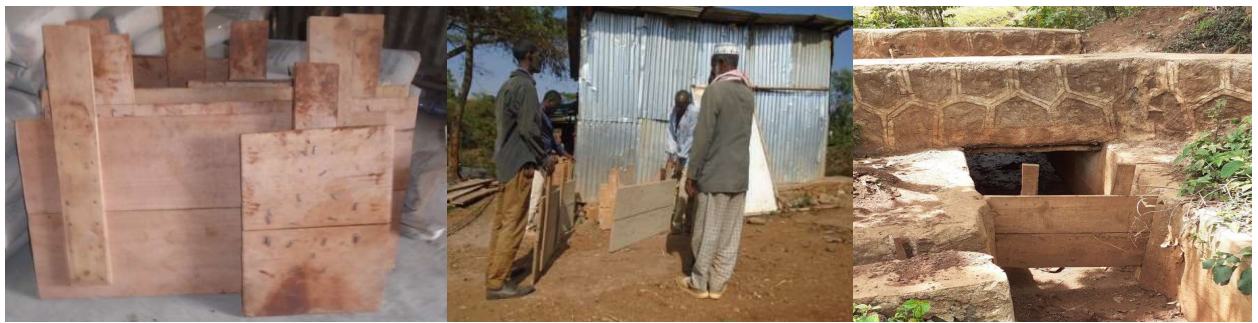
Water conveyed through the canal system to the farm land needs to be equitably distributed among the canals or farm plots. Division boxes are designed to function as water dividing structure and water diverted through each outlet of the structure in a controlled manner in amount and frequency. The gates are designed to be prepared from locally available materials such as wooden timbers. Accordingly, 34 planned canal gates were totally installed and 100% completed.

Fig 17: Division box gates fixed into the division boxes slots

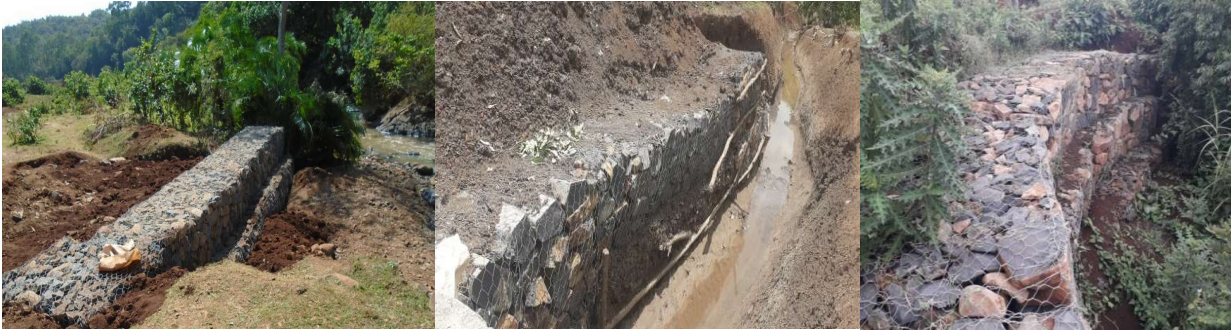
Protection works by gabion was planned to protect or strengthen fragile soil part. The susceptible part of the area are found along the river banks where the river banks and canal tends to approach each other and the water coming from both the river and canal moistens soil at banks and finally causes the river bank to collapse. This problem is very high at the space where the gap between river bank and canals become narrow. Thus, protection works at these specified areas had been done and protect the fragile soil.

In order to protect the sliding canal embankment areas, the project installed gabion structure at the upper side of the right side branch canal. The soil at this area is so very clay it attempt to be cracked during dry periods and soon loses its strength when getting water or rain in the wet season. To cope up this risk, the project plan to install 600m³ gabion structures and perform 254m³ gabion structure to support the upper canal embankments and river bank side walls.

Figure 18: River Bank and canal embankment Protected by Gabion wire

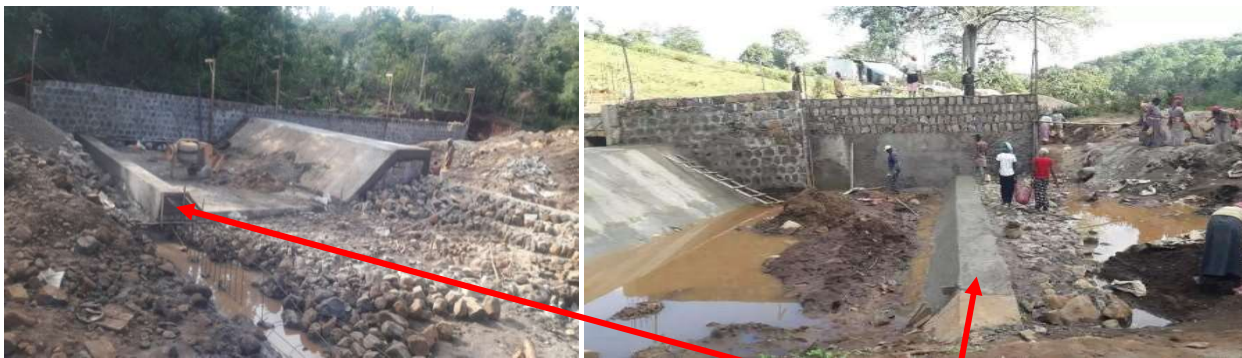
In order to support the impervious apron below the concrete apron to support the weir system, 132m³ gabion structure has been planned to install in the year. Accordingly, the project construct 132m³ concrete after the end sill instead of gabion boxes to adjust the level between river bed and the concrete apron end sill which is part of the weir body.

Fig 19: concrete end sill constructed

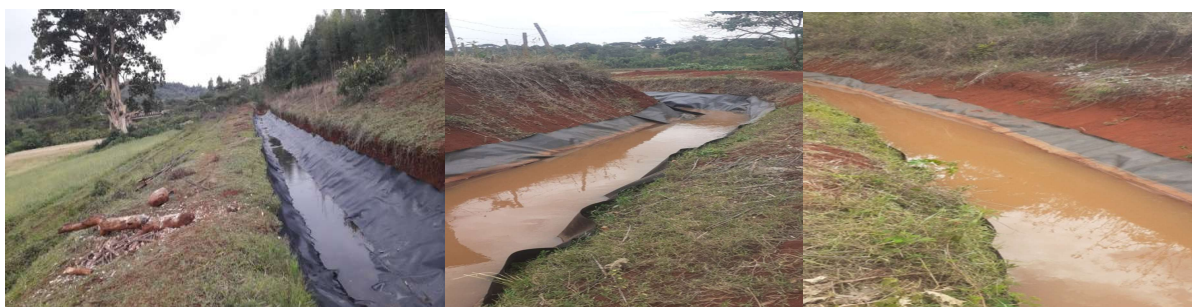
The canal both the main and branch were done as per its engineering design and with care but when the irrigation water is let to flow along its length water leakage is identified both at right and left side branch canals. To avoid this risk many options are applied to close the leakage areas but the risk is continued even though doing some mitigation measures. Finally, the project is decided to close or cover the leakage areas with Geo-membrane sheets so as to stop the risk and continuing irrigation application. Accordingly, 14 roles of Geo-membrane sheets were bought from Addis Ababa water works manufacturing industry and has made to cover 1.9km all identified canal leakage areas both at right and left side branch canal areas. In doing this, leakage risks are avoided and achieved leakage free delivers of water to the intended farm areas.

Fig 20: Leakage canal areas protected by covering with Geo-membranes

- Awareness/ orientation about Covid-19 caution measures given to target beneficiaries. Supply of face masks and sanitizer during training and labour work.
- To avoid water leakage, the project tried to close mole holes along the canal but couldn't succeed and finally the canal areas both at right and left sides which invite or expected the leakage risks covered with Geo-membrane sheet and was attained smooth flow of water in the canal.

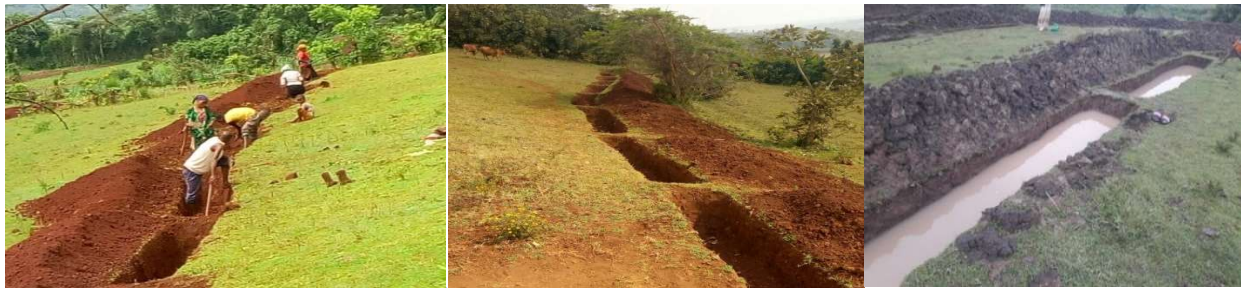
Taking this into consideration, the project has planned to excavate 10km soil bund in the year and completed 8.175km soil bunds or 81.752 of the plan. The soil bunds are constructed in the farm lands that found above the main and branch canals at the farmland and bare lands covered with scattered bushes. This structure will keep safe the canal as well as farmlands areas from soil erosion and canal silt up with sediments which may block the smooth flow of the canal water to the farm areas.

Figure 27: Soil bunds excavated to protect the canal and canal structures

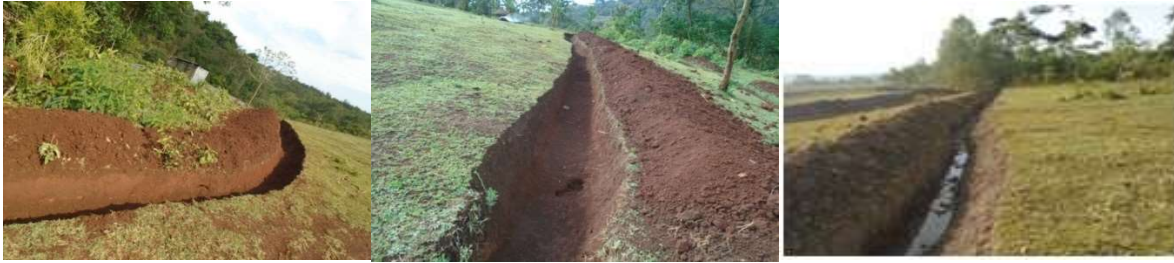
As most of the areas above the canal catchment areas are prone to floods, cut off drain is playing an important role to mitigate the flood risks on soil bunds, canals and farm areas by collecting and draining the incoming flow safely into rivers and/or other water ways before entering and silting in the canal system. In the project periods, it was planned to excavate 300m³ of cut off drain and hence 335m³ of cut off drain structure is excavated by the project which is 117% of the year plan.

Fig 28: Cut off drains excavated above the canal areas

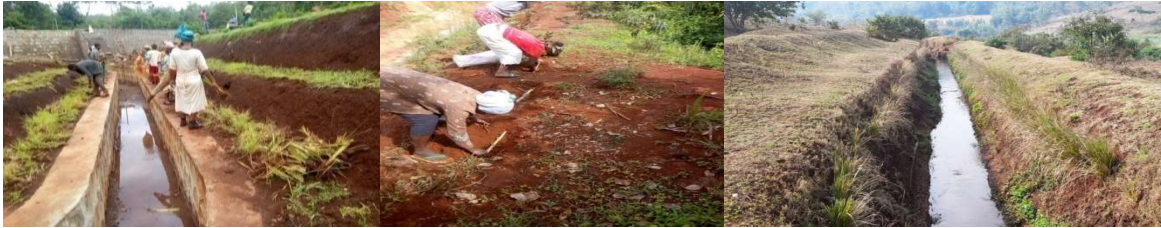
Vetiver grass has a capacity to protect the canal as well as an area which is suspected for land slide during the rain by the effect of erosion and land slide problems. To cope up this problem, the project planned 14,158 vetiver grass splits at both side of the canal and lose soil areas both at the right and left side branch canal areas and in addition to these 946 Elephant grass planted at the canal areas where it is near to the river side.

Fig 31: Vetiver planted at the canal and soil bund embankment

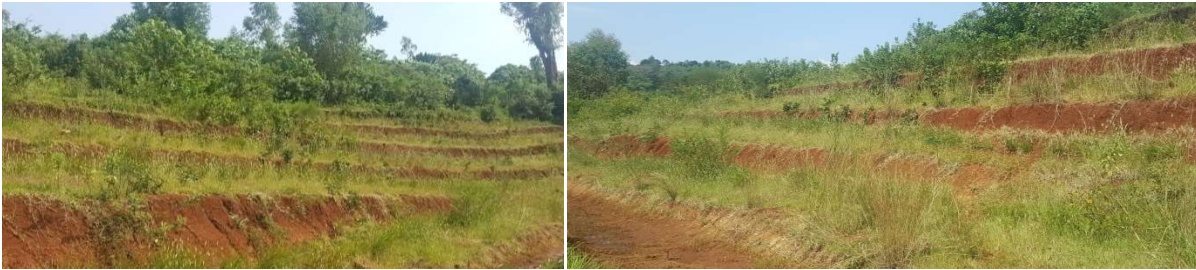
Currently, the vetiver grass planted is established well and grows fast to cover the bench areas as shown below in the pictures.

Figure 32: Vetiver grass planted in the bench cuts
