Support for Sustainable Development (SSD)

Terminal report Of Gibe-kechema Irrigation Based Integrated Development Project (1st January2019 – 31st March 2022)

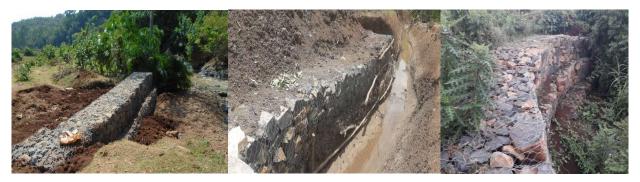
Figure 18: River Bank and canal embankment Protected by Gabion wire

In order to protect the sliding canal embankment areas, the project installed gabion structure at the upper side of the right side branch canal. The soil at this area is so very clay it attempt to be cracked during dry periods and soon loses its strength when getting water or rain in the wet season. To cope up this risk, the project plan to install 600m³ gabion structures and perform 254m³ gabion structure to support the upper canal embankments and river bank side walls.

Protection works by gabion was planned to protect or strengthen fragile soil part. The susceptible part of the area are found along the river banks where the river banks and canal tends to approach each other and the water coming from both the river and canal moistens soil at banks and finally causes the river bank to collapse. This problem is very high at the space where the gap between river bank and canals become narrow. Thus, protection works at these specified areas had been done and protect the fragile soil.

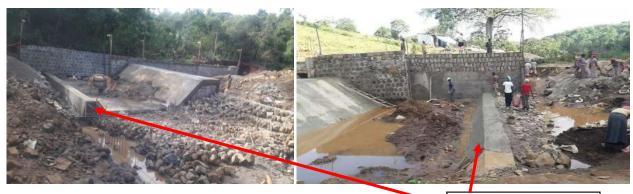
Fig 19: concrete end sill constructed

In order to support the impervious apron below the concrete apron to support the weir system, 132m³ gabion structure has been planned to install in the year. Accordingly, the project construct 132m³ concrete after the end sill instead of gabion boxes to adjust the level between river bed and the concrete apron end sill which is part of the weir body.

Concrete end sill
